**METALLURGICAL TECHNOLOGIES, Inc.**  
*A Rimkus Company*

**Report Number 2021104**  
**January 21, 2021**

**Re: Salt Spray Testing of a EZ Claw Cable Retention Assembly**

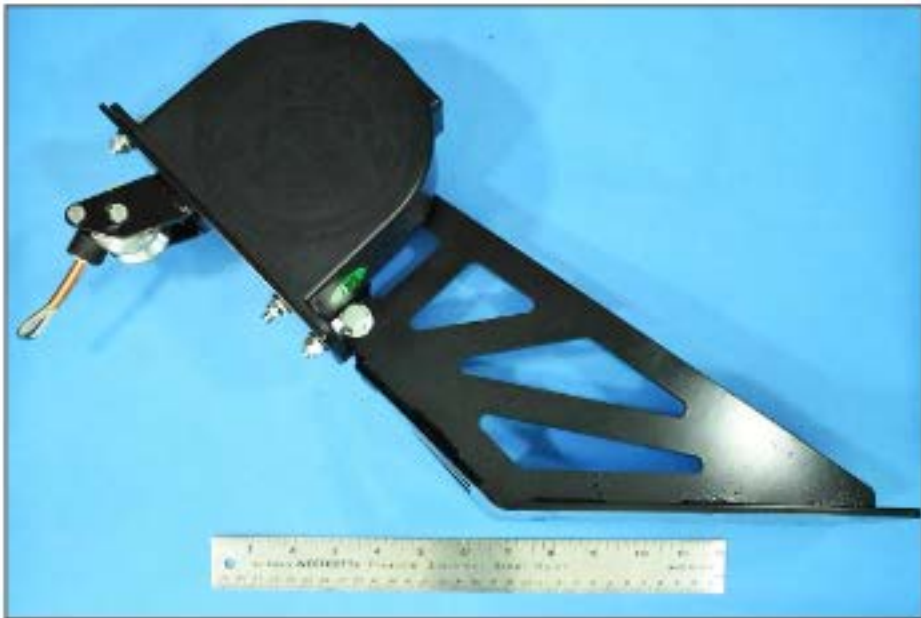
Figure 1: Photograph of the EZ Claw assembly prior to salt spray testing. The assembly was subjected to 120 hours of salt spray testing. (Photo 21104-N11)

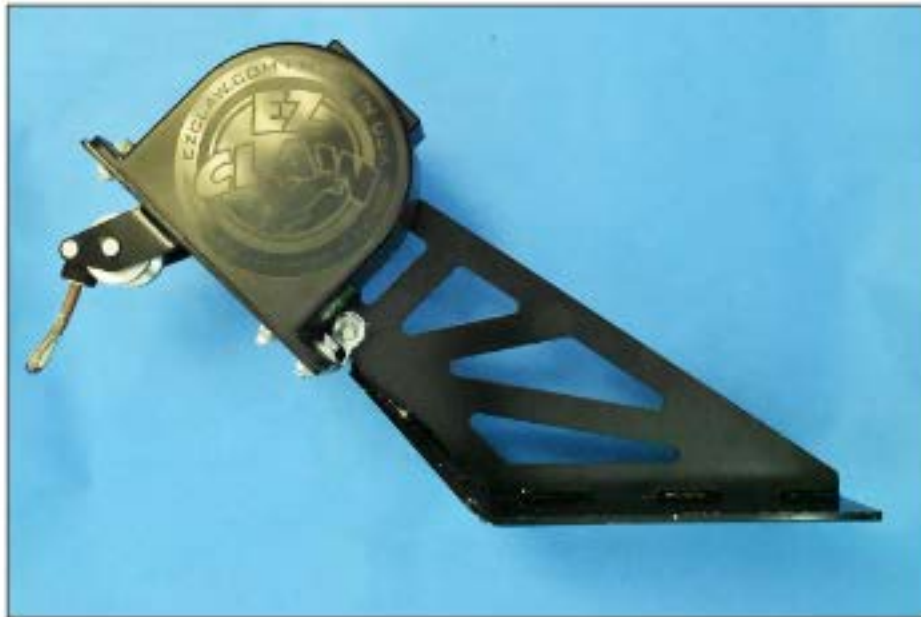
At the conclusion of the 120-hour test, the assembly was gently rinsed with deionized water to remove any remaining salt deposits. The assembly had no indication of red rust corrosion. As expected, a significant amount of white zinc oxide deposits were visible across the majority of the exposed fasteners.

Figure 2: Photograph of the EZ Claw assembly after the completion of 120 hours of salt spray testing. No indication of red rust was visible. A closer view photograph of the retraction assembly is shown in Figure 3. (Photo 2021104-N26)

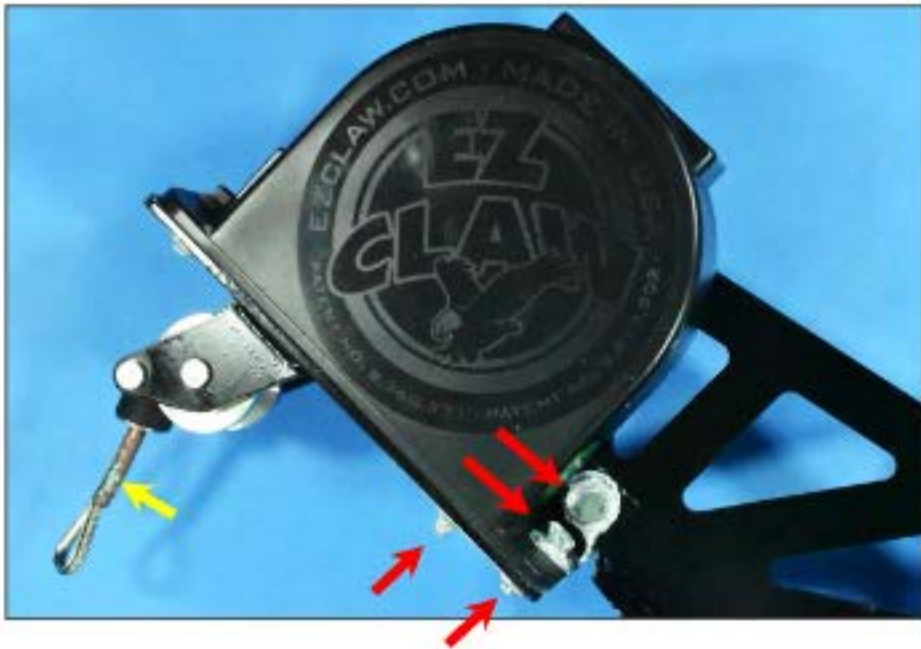
Figure 3: Closer view photograph of the EZ Claw retraction assembly after the completion of 120 hours of salt spray testing. No indication of red rust was visible. The white deposits (red arrows) around the fasteners are zinc oxide and are expected in zinc plated components. Additionally, an expected green copper oxide deposit (yellow arrow) was observed on the copper wire crimp. (Photo 2021104-N27)
