# METALLURGICAL TECHNOLOGIES, Inc.

## Report Number 2021104 January 21, 2021

### Re: Salt Spray Testing of a EZ Claw Cable Retention Assembly

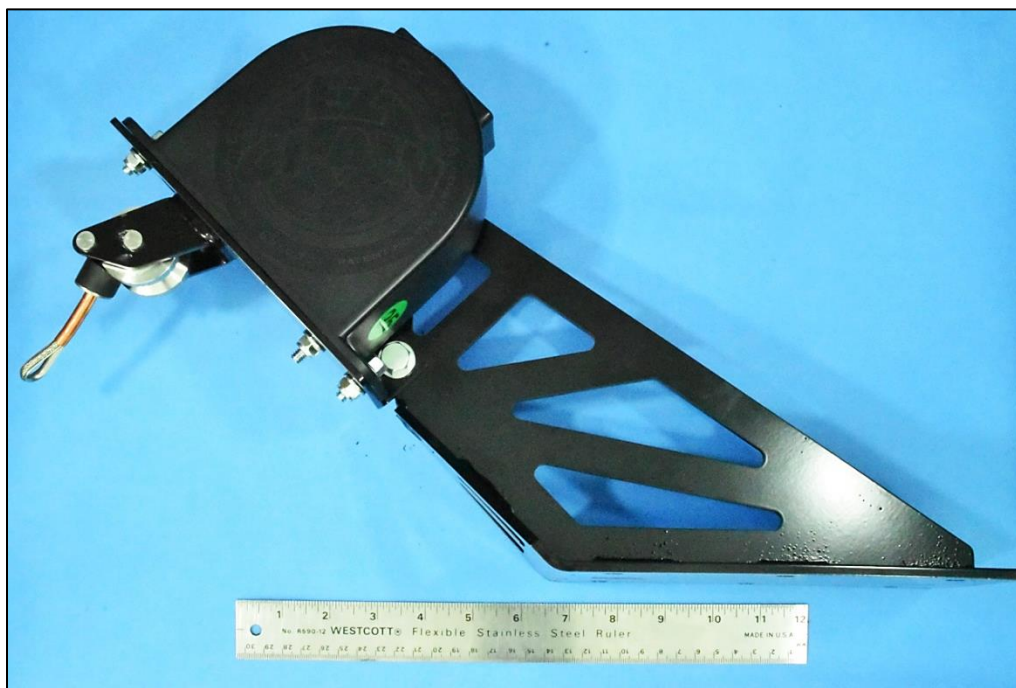
Figure 1: Photograph of the EZ Claw assembly prior to salt spray testing. The assembly was subjected to 120 hours of salt spray testing. (Photo 21104-N11)

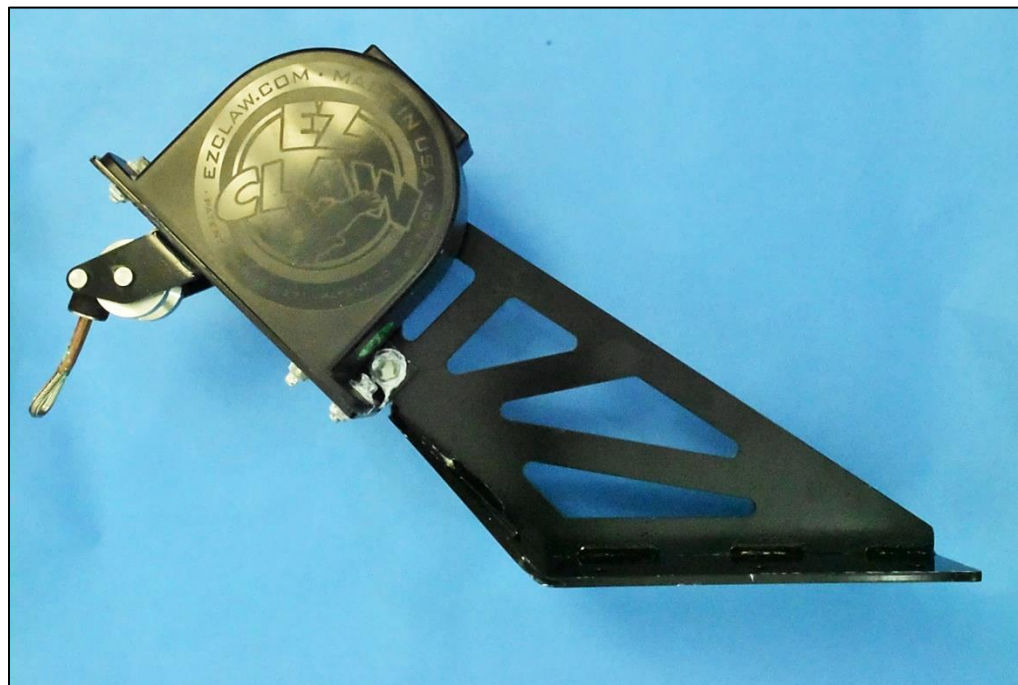
At the conclusion of the 120-hour test, the assembly was gently rinsed with deionized water to remove any remaining salt deposits. The assembly had no indication of red rust corrosion. As expected, a significant amount of white zinc oxide deposits were visible across the majority of the exposed fasteners.

Figure 2: Photograph of the EZ Claw assembly after the completion of 120 hours of salt spray testing. No indication of red rust was visible. A closer view photograph of the retraction assembly is shown in Figure 3. (Photo 2021104-N26)

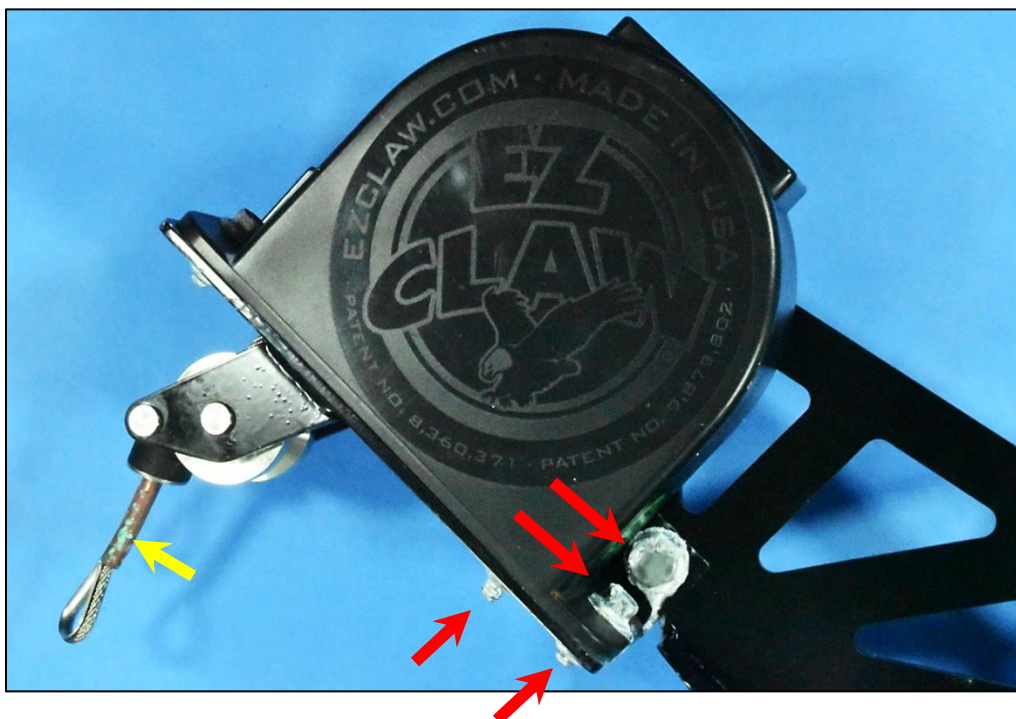
Figure 3: Closer view photograph of the EZ Claw retraction assembly after the completion of 120 hours of salt spray testing. No indication of red rust was visible. The white deposits (red arrows) around the fasteners are zinc oxide and are expected in zinc plated components. Additionally, an expected green copper oxide deposit (yellow arrow) was observed on the copper wire crimp. (Photo 2021104-N27)
